DDR Problem Solution

Release Version: 1.0

Preface This document provides the DRAM debug method, which is suitable to all Rockchip chips.

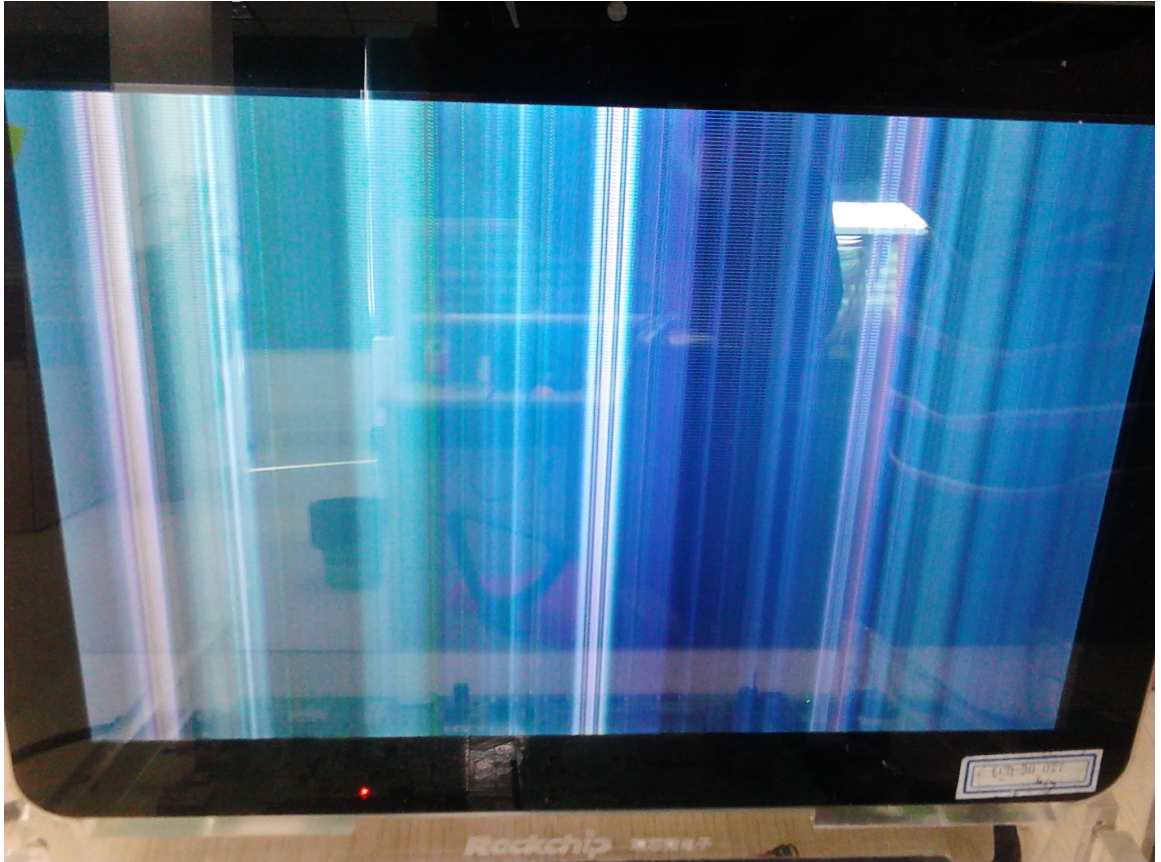
1. If display normal, it means that the DDR can be accessed normally, but it does not mean that the crash is not related to the DDR.
2. If display by mistake:
 - As the picture as shown below, it may be that the DDR is in an inaccessible state during the DDR frequency scaling process. At this time, you can try fixing the DDR frequency. Or it may be

DDR controller logically error caused by power issue.

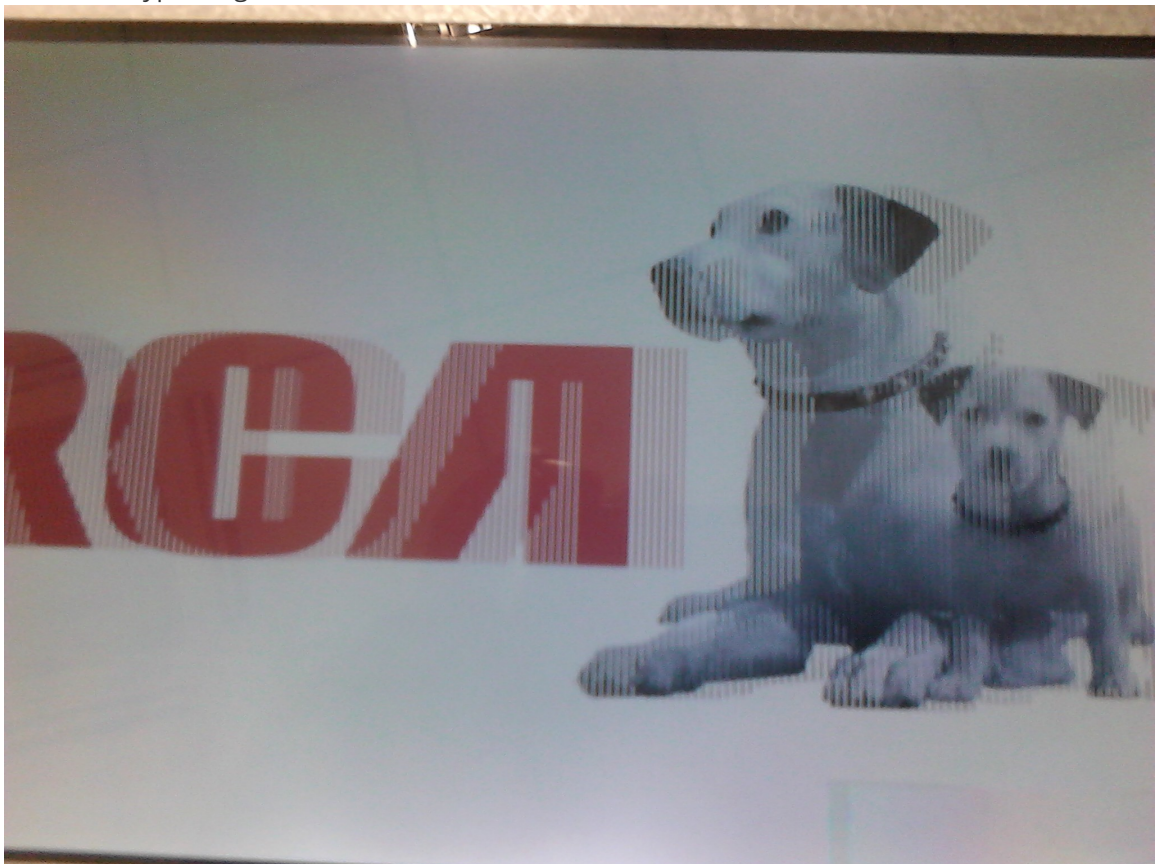
- As shown picture below, we call it "Ghosting", there is a similar situation triggered by the incompleted reference layer of the board. The way to fix it is trying raise the `VCC_DDR` voltage to 1.6V or bypassing the dll of DDR.
